How CRAs now support the **Statue of Liberty**

Built in 1886, the copper-clad Statue of Liberty has required quite some maintenance and renovation to keep it in pristine condition. In 1986, for example, engineers decided to replace rusty iron components with advanced materials such as Ferralium and 316L.

By David Sear

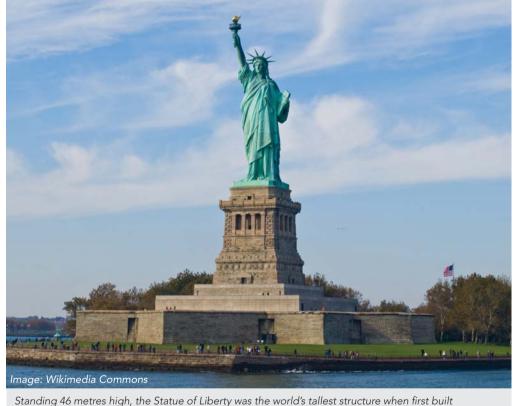
Standing 46 metres high, the Statue of Liberty was the world's tallest structure when first built
